**Flood Control Project Maintenance
Levee Inspections**

Fall 2009 Levee Maintenance Deficiency Summary Report

Reclamation District No. 2094 Wathal

Levee Inspection Report By Mile - Fall 2009

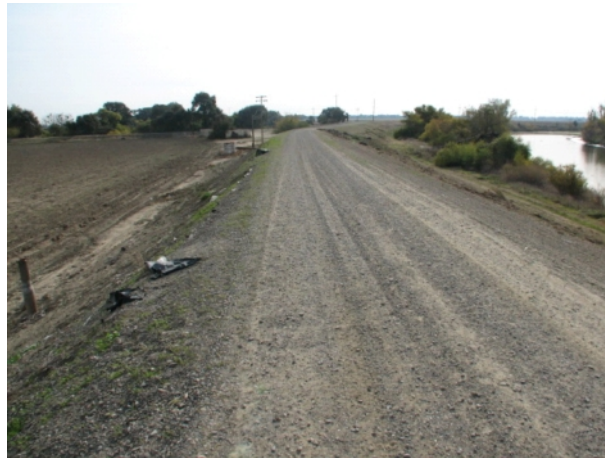
Levee Mile Report Line	1
Start Levee Mile	0.59
End Levee Mile	0.59
Location	Land Side
Category	Earthen Levee
Item	Slope Stability

LMR No	Levee Mile		Category	Item	Location *	Rating **	Action/Comment	GPS Latitude/Longitude		Issue No.
	Start	End						Start	End	Photo
1	0.59	0.59	Earthen Levee	Slope Stability	LS	A	Repair slope instability. Inspector Comments: District representative requested notation made that the waterward slope of the bank is a gentle slope but the landward slope is steep.	37.768143 ° -121.295829 °	37.768143 ° -121.295829 °	6 Y
2	0.65	0.65	Earthen Levee	Vegetation	LS	A	Remove the wild growth other than native grasses from the levee slopes. Inspector Comments: Vegetation maintenance program consists of dragging an anchor chain along the slope. The surface of the slopes will need to be watched to see that the levee is not unintentionally degraded.	37.767642 ° -121.295063 °	37.767642 ° -121.295063 °	7 Y
3	1.12	1.12	Earthen Levee	Erosion / Bank Caving	WS	M	Schedule repair of erosion site prior to the next inspection.	37.761845 ° -121.295311 °	37.761845 ° -121.295311 °	9 Y

View of steep landward slope.

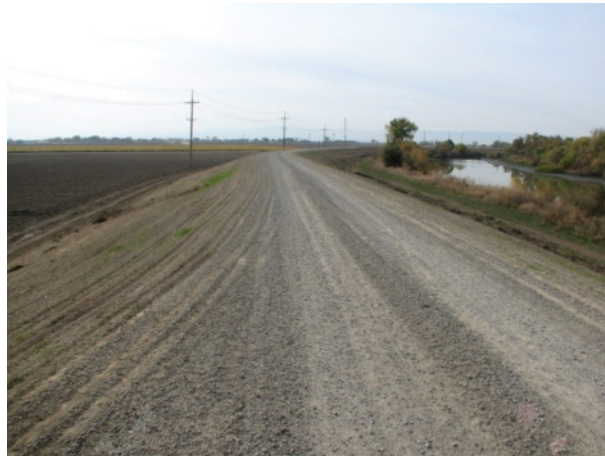
Levee Mile Report Line	2
Start Levee Mile	0.65
End Levee Mile	0.65
Location	Land Side
Category	Earthen Levee
Item	Vegetation

Example of the good vegetation management along the unit.

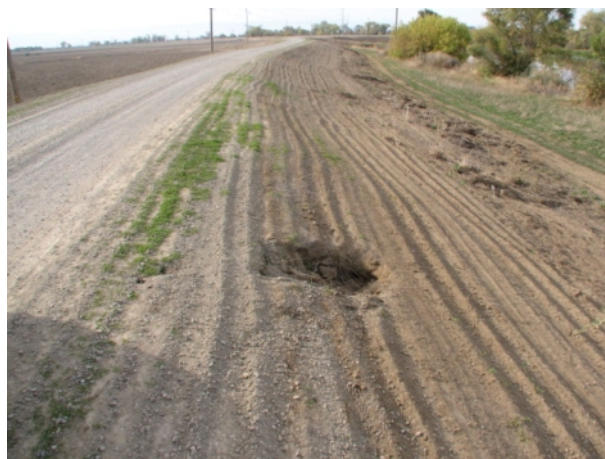
Levee Mile Report Line	3
Start Levee Mile	1.12
End Levee Mile	1.12
Location	Water Side
Category	Earthen Levee
Item	Erosion / Bank Caving

Cave in of animal burrow has created a slope stability concern.
